Powderpost beetles in timber

protecting timber, buildings and furniture

Timber borers 1

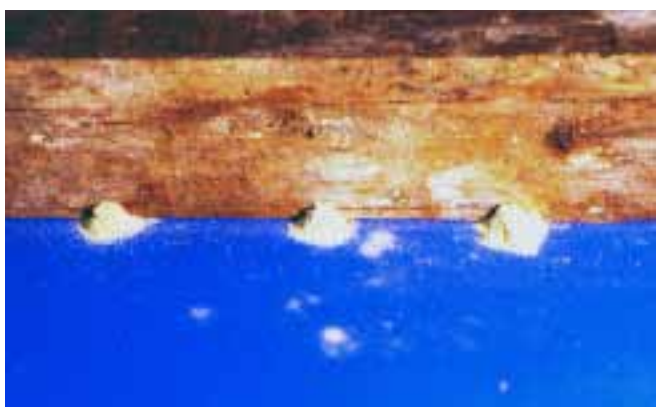
Figure 1. Larvae of powderpost beetles can reduce susceptible timber to a fine flour-like powder.

Powderpost beetles belong to the subfamily Lyctinae in the family Bostrichidae. They are so named because their larvae can reduce susceptible timber to a fine flour-like powder (Figure 1).

Most attacks take place at the saw-mill, in logs or sawn timbers that are drying. Evidence of infestation may not become apparent until the timber is in-service and adults begin to emerge. Infested timber contains numerous galleries packed with fine powdery frass. The whole of the infested area may be reduced to powder leaving only a shell of wood on the outside, perforated by emergence holes. Small piles of frass may be found where a gallery has broken the surface or where an adult beetle has emerged. The frass is smooth and floury (not gritty) when rubbed between the fingers. Infestation may occur anywhere in the structure where susceptible timber has been used (for example, in subfloor areas, living space, roof space, or in furniture and artefacts). In new houses, emergence holes may appear in the lining materials (for example, in plasterboard and panelling) and joinery. Such holes are made by adults emerging from the hardwood framing beneath.

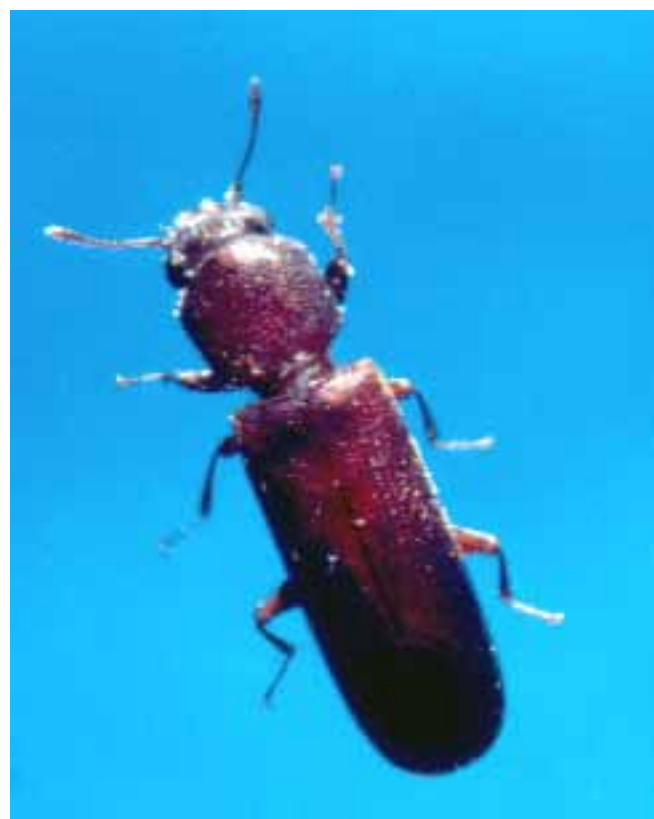
Figure 2. Adult powderpost beetle *Lyctus brunneus*.

Adults are up to 7 mm long, dark-brown, shiny, flattened, elongate insects (Figure 2). They have a distinct head and the terminal segments on their antennae have a clubbed appearance. Larvae are cream-coloured with brown head and jaws and 3 pairs of small jointed legs. On hatching, they are about 0.5 mm long and straight-bodied but later become C-shaped.
